Slow Seat Belt Retraction. 2006 to 2011 Miatas

Category S	Repair Guidance	Ref. No. R086/10A	Page 1 of 3
Coverage <input type="checkbox"/> Distributor only <input checked="" type="checkbox"/> Please inform your dealers		Date Issued October 29, 2010	
Please convey this information to your <input type="checkbox"/> Director <input checked="" type="checkbox"/> General Manager <input checked="" type="checkbox"/> Warranty Dept. <input checked="" type="checkbox"/> Parts Dept. <input checked="" type="checkbox"/> Training Dept. <input checked="" type="checkbox"/> Field Rep.		Date Revised December 8, 2011	
Applicable Model MX-5/Miata (NC)		Applicable Countries or Specifications Worldwide

Subject: Poor Seat Belt Retraction

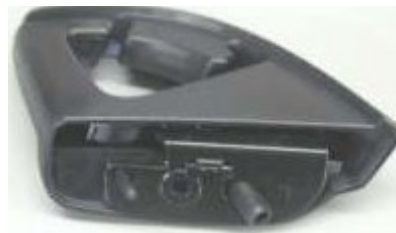
*** Always replace belt guide and protector simultaneously because shapes of the belt guide are different.

NHY8 88 1L7	Belt Guide (Right)	1	(Plastic Guide)
NHY8 88 1M7	Belt Guide (Left)	1	(Plastic Guide)
NHY8 88 1J1	Protector (Right)	1	(Metal Support)
NHY8 88 1K1	Protector (Left)	1	(Metal Support)

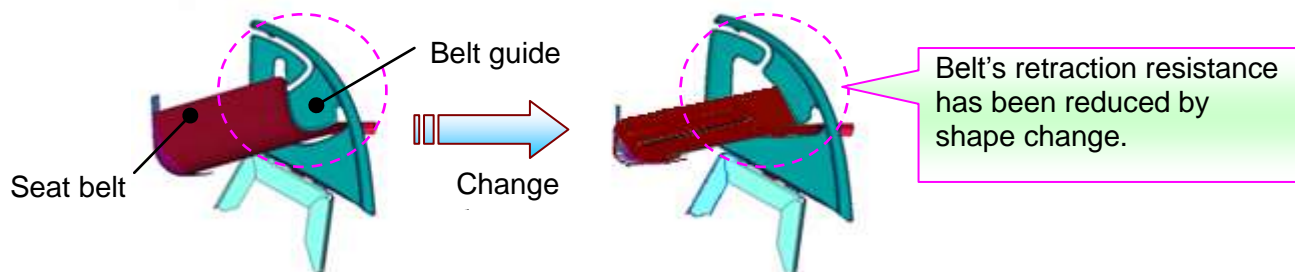
Note: *The shape of the belt guide (Service parts) has been changed as illustration.

(2) Assembly new seat belt guide & new protector, then install it using original screw.
