Rain Leak Area Under Cowl Cover

Foam gasket dries out with age.

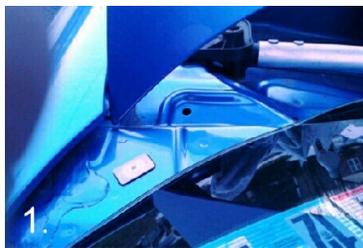
This problem is caused by the thin foam seal under the top of this plastic grommet which can be seen in the top left of picture 3. The foam is drying out, and during a hard rain some water leaks down onto the front floor mat. The water then starts to cause metal parts under the dash to rust. See the location of the "grommets" in picture #1 of the Driver's side, and #2 of the Passenger's side.

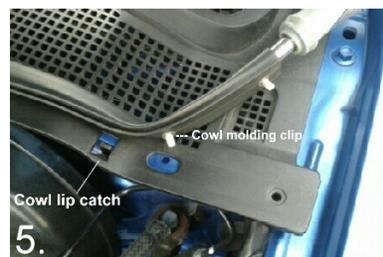
Along the front edge of the cowl cover is a hollow rubber molding which seals up against the underside of the hood. There are small white plastic clips which go down thru the cowl cover and into the sheet metal of the cowl itself. See picture #5. Get your fingers under the cowl lip and squeeze the end of the white plastic clips while pushing up to remove the molding. Then pull the cowl cover forward lifting the front edge up slightly. There are clips under the windshield and under the cowl cover front lip that will loosen when you pull it forward & up. When these clips are loose, you can fold the cowl upward in the middle (See picture #4) to pull it into the engine compartment. Watch for the wiper fluid tubing on the passenger's side so you do not damage it.

After the Silicone Form-A-Gasket is cured, carefully slide the black plastic cowl cover back into place. When the cowl cover is almost back into it's final position, lift the front of the cowl cover a little to get the clips along the back edge of the cowl cover to go under the bottom edge of the windshield. Be careful you do not bend those rear "under windshield" clips, or the cowl cover will not stay down in place. If you do bend one of the rear clips, you will know because you will not be able to push the cowl back in place. Once the cowl cover is back in place, make sure the clips along the front edge of the cowl cover (See Picture #5) are under the metal cowl lip.. Now put the hollow rubber molding back in place.
