Braided Reinforced Clutch Line Installation Tips.

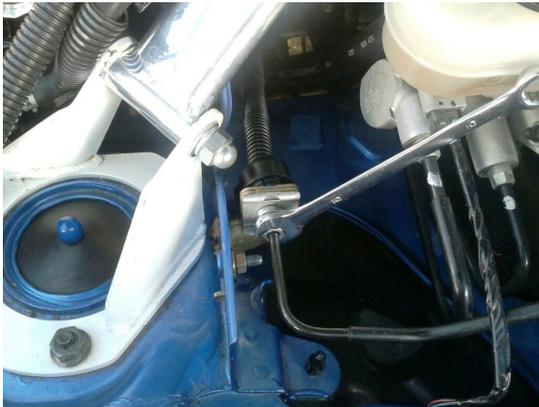
To be prepared for leaking brake/clutch fluid, I wrapped a paper towel under the fitting you see in the picture below left. Then I put another crumpled paper towel in a small zip-lock bag.

You can see in the picture below left, I used an open-end 10mm wrench to loosen the clutch line where it goes into the OEM flexible part that goes down towards the motor. These are regular right hand threads so turn the wrench to the left to loosen it. When I got the line off, I stuck the hard tubing end in the zip lock bag with paper towel to catch any dripping. Be careful the bag doesn't fall over and let clutch fluid drip out. Brake fluid is very hard on paint.

Right behind the wrench in the left picture is a "horseshoe" shaped clip. Pull up on that with pliers and the top of the OEM flexible hose is now free. It helps to have this free when working on the bottom.

Now go up to the fitting under the hood, as seen in the picture above left. The A/C hose made the braided clutch line seem a little short. I adjusted the upper bracket to move closer to the motor about 3/16" when bolted in place. Then I put the hex end of the braided line into the bracket and installed the horseshoe clip. Last I put the solid tube end fitting into the braided end and tightened it.

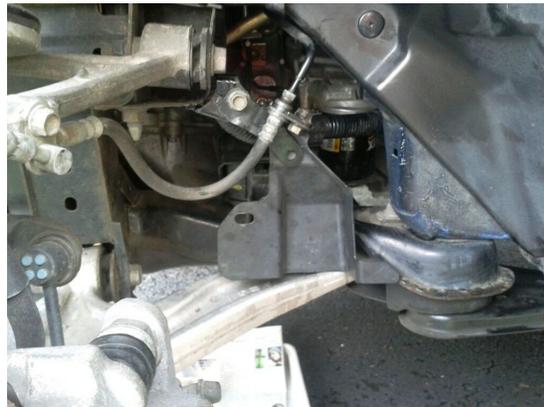
The next step is down below in the wheel well, after you remove the driver's side wheel. The bottom fitting is accessible from the wheel well. See in the picture above top right. See the small plastic cover near where the brake line comes out of the engine compartment. There is a "1/4 turn" plastic pop-out fastener holding the front of the small plastic cover, but I could not see how it was held to the rear of the cover. I found there were 2 plastic tabs that stuck into the square opening you see to the rear of where the cover is placed. Not knowing what was there, I pried on it trying to look, and the tabs broke off. I don't know how to tell you to avoid this. But you need to remove this cover.

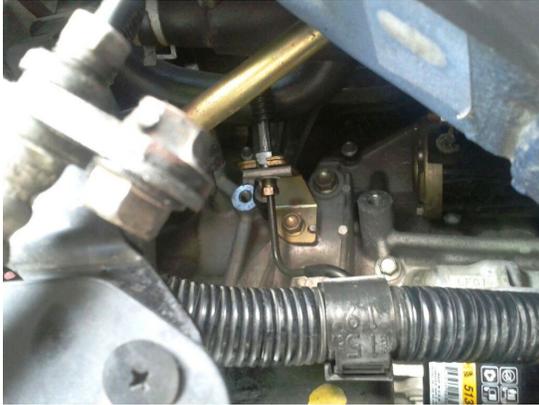
See the picture above, bottom left. The bottom fitting and bracket is accessible thru the opening created by removing the small cover. I wrapped a paper towel around the bottom metal tube and loosened the bottom fitting. After this is loosened, there is another horseshoe clip to pull straight out. Now that the bottom fitting is totally loosened, you can remove the OEM flexible hose from the top or bottom of the car. You will note all the fluid that was in the OEM hose soaked this bottom paper towel, so remove it and keep it away from all paint.

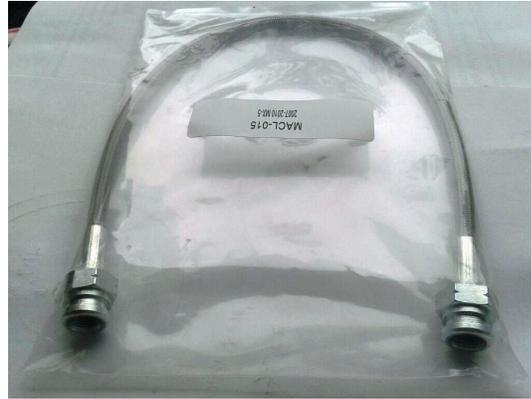
You will note each end of the new braided cable has a hex fitting on it. See above picture bottom right. There is a matching hex recessed opening in each of the mounting brackets. Make sure the hex end fits into the recessed opening of the bracket, as this is what holds it from turning while you tighten the fitting into it.

Start with the bottom first. Put the hex fitting into the bracket, and put the horseshoe clip in place to hold it. Note the horseshoe clip is not flat, so put the curved side away from the bracket. Now put the solid tube end up into the braided fitting and carefully tighten it. Make sure it starts easily so it is not cross threaded. It will leak if it is cross threaded.
