Slow Seat Belt Retraction. 2006 to 2011 Miatas

Category S	Repair Guidance	Ref. No. R086/10A	Page 1 of 3
Coverage <input type="checkbox"/> Distributor only <input checked="" type="checkbox"/> Please inform your dealers		Date Issued October 29, 2010	
Please convey this information to your <input type="checkbox"/> Director <input checked="" type="checkbox"/> General Manager <input checked="" type="checkbox"/> Warranty Dept. <input checked="" type="checkbox"/> Parts Dept. <input checked="" type="checkbox"/> Training Dept. <input checked="" type="checkbox"/> Field Rep.		Date Revised December 8, 2011	
Applicable Model MX-5/Miata (NC)		Applicable Countries or Specifications Worldwide

Subject: Poor Seat Belt Retraction

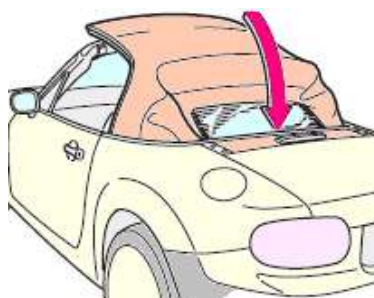
Dirt, dust or smudges increases the friction between the belt guide in the seat back shoulder area or the anchor area and the seat belt, and may cause the poor retraction.

Clean the seat belt, belt guide, anchor and etc. of the affected seat belt. If this action does not solve the issue, replace right and left belt guide and protector with the improved ones. For details, refer to the following procedures.

Note: Opening the convertible top enhances the accessibility.
