Rain Leak Area Under Cowl Cover

Foam gasket dries out with age.

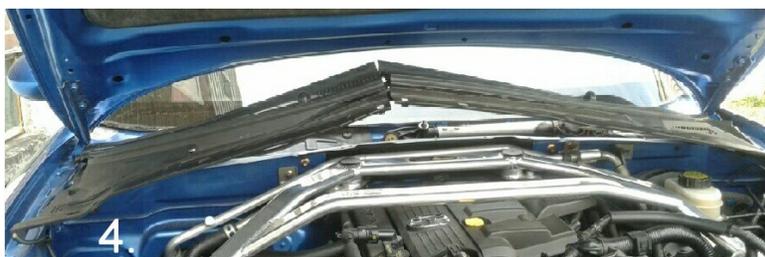
Along the front edge of the cowl cover is a hollow rubber molding which seals up against the underside of the hood. There are small white plastic clips which go down thru the cowl cover and into the sheet metal of the cowl itself. See picture #5. Get your fingers under the cowl lip and squeeze the end of the white plastic clips while pushing up to remove the molding. Then pull the cowl cover forward lifting the front edge up slightly. There are clips under the windshield and under the cowl cover front lip that will loosen when you pull it forward & up. When these clips are loose, you can fold the cowl upward in the middle (See picture #4) to pull it into the engine compartment. Watch for the wiper fluid tubing on the passenger's side so you do not damage it.

After the Silicone Form-A-Gasket is cured, carefully slide the black plastic cowl cover back into place. When the cowl cover is almost back into it's final position, lift the front of the cowl cover a little to get the clips along the back edge of the cowl cover to go under the bottom edge of the windshield. Be careful you do not bend those rear "under windshield" clips, or the cowl cover will not stay down in place. If you do bend one of the rear clips, you will know because you will not be able to push the cowl back in place. Once the cowl cover is back in place, make sure the clips along the front edge of the cowl cover (See Picture #5) are under the metal cowl lip.. Now put the hollow rubber molding back in place.
