APRIL 2010

Check Your Manual Shifter Boots!

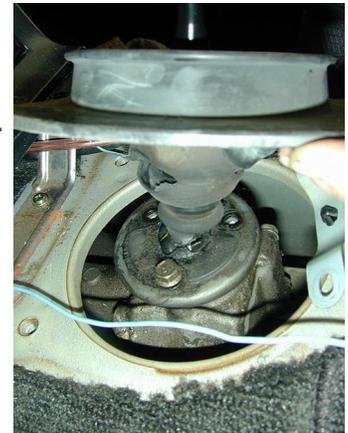
Under the large boot is the small one (See picture of the small boot). This keeps dirt and moisture out of the tranny. Note the 1989 to 2005 Miata (NA & NB) has this small boot. The 2006 (NC) and newer does not. If it is cracked, remove the 3 bolts and take the small boot off. You may have to cut it off of the shifter shaft as it is a tight fit.

The easiest way to remove the small boot is to put the tranny in neutral and just pull the shifter straight up and out of the tranny. Before you pull the shaft up out of the tranny,

The only way I have found to install a new bottom boot on the shifter is to put Vaseline on the shifter and push the small boot down over the shaft. It should be positioned just under the large, widest section. You may look at the small hole in the small boot and say "No Way", but it will go down over the shaft. The Vaseline helps a lot.
